Italian HEMS AW139 Inadvertent IMC Accident

A leased [Leonardo Helicopters AW139](#), EC-KJT, was operated by [INAER Aviation Italia](#) (a [Babcock](#) company) from [L'Aquila](#) in the Abruzzo region of Central Italy to provide a daytime Helicopter Emergency Medical Service (HEMS) service. It crashed into a mountain during a HEMS mission on 24 January 2017. The [Agenzia Nazionale per la Sicurezza del Volo \(ANSV\)](#) released their [accident investigation report \(in Italian only\)](#) in May 2018.

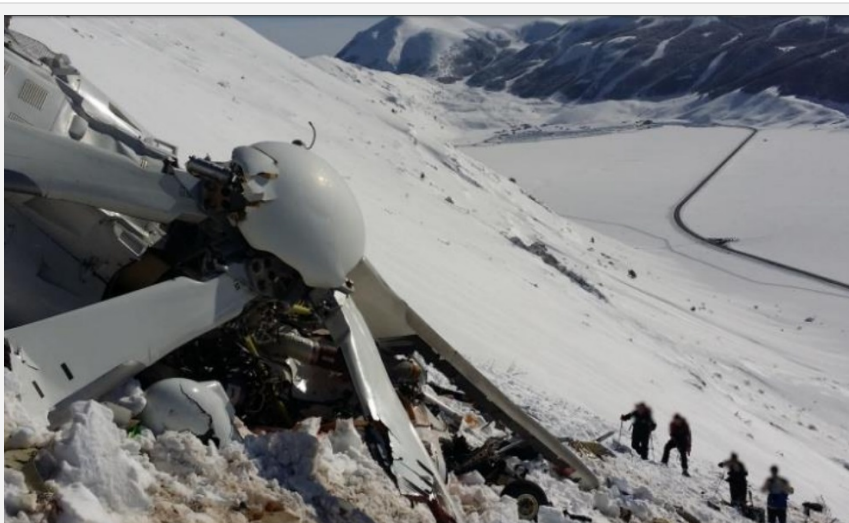
Wreckage of HEMS Leonardo AW139 EC-KJT of INAER Aviation Italia (a Babcock company) on Mount Cefalone
(Credit: ANSV)

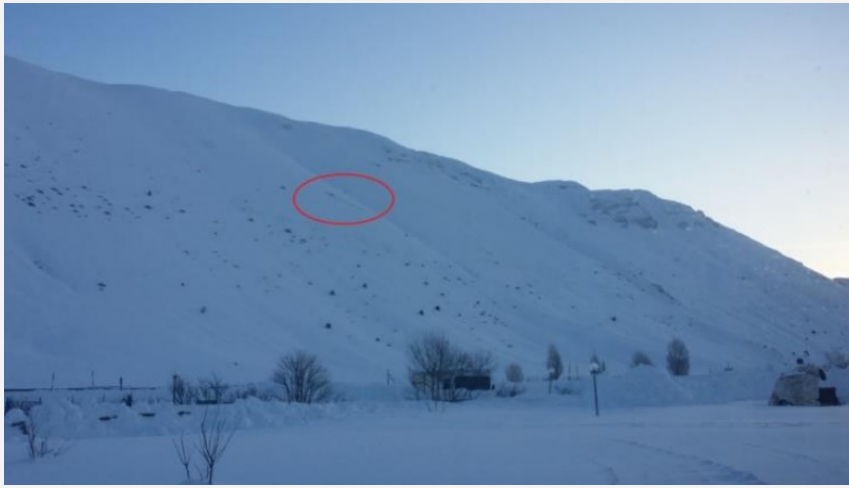
The helicopter then turned towards high ground and impacted against the south-west side of Monte Cefalone at c10:25:43, less than 2.5 minutes after take off.

Accident Site of HEMS Leonardo AW139 EC-KJT of INAER Aviation Italia (a Babcock company) on Mount Cefalone
(Credit: ANSV)

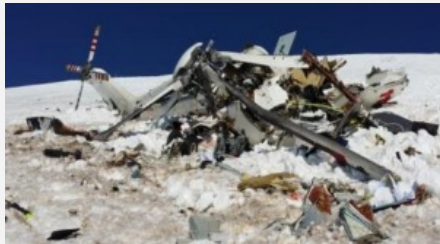
Wreckage of HEMS Leonardo AW139 EC-KJT of INAER Aviation Italia (a Babcock company) on Mount Cefalone
(Credit: ANSV)

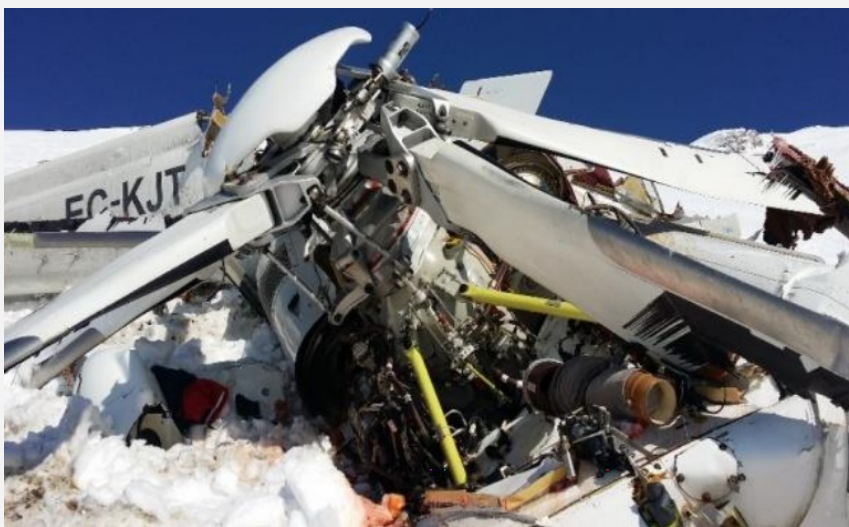
Wreckage of HEMS Leonardo AW139 EC-KJT of INAER Aviation Italia (a Babcock company) on Mount Cefalone
(Credit: ANSV)

The accident was caused by the impact of the helicopter on the South-West slope of the Mount Cefalone in only partially controlled flight conditions.
