Italian HEMS AW139 Inadvertent IMC Accident

A leased [Leonardo Helicopters AW139](#), EC-KJT, was operated by [INAER Aviation Italia](#) (a [Babcock](#) company) from [L'Aquila](#) in the Abruzzo region of Central Italy to provide a daytime Helicopter Emergency Medical Service (HEMS) service. It crashed into a mountain during a HEMS mission on 24 January 2017. The [Agenzia Nazionale per la Sicurezza del Volo \(ANSV\)](#) released their [accident investigation report \(in Italian only\)](#) in May 2018.

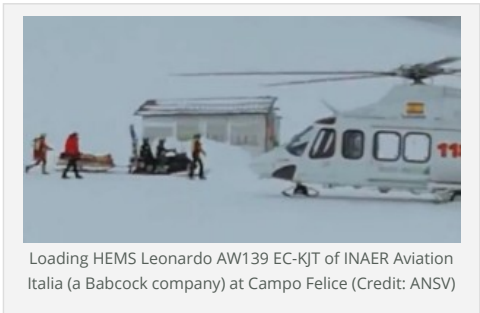
The aircraft however successfully landed at 10:16 and remained rotors running with only only the pilot aboard as the medics and TCM collected the patient.

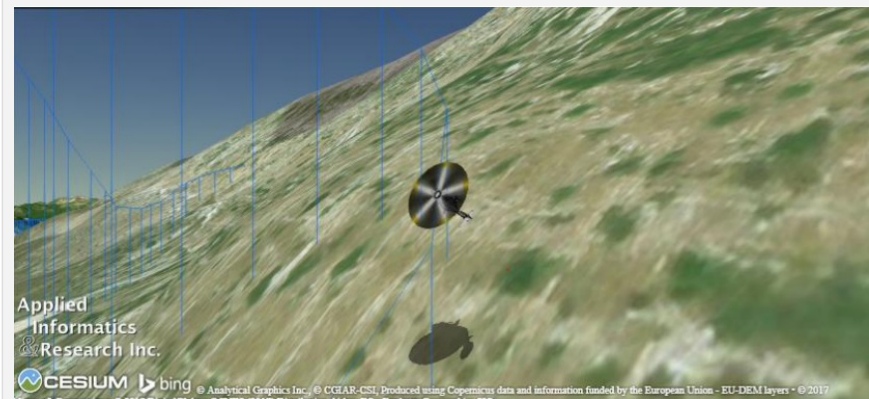
The aircraft almost collided with terrain about this time (the minimum recorded radalt altitude was 24 feet). The impact was avoided and the aircraft climbed to 600 feet AGL and entered a turn. The torque values of both engines reached very high values (up to 144%) and remained very high and well beyond limits, never falling below 114%, until the final impact. After this escape manoeuvre, the helicopter flight is characterised by the ANSV as “one of significant instability of the main flight parameters”.

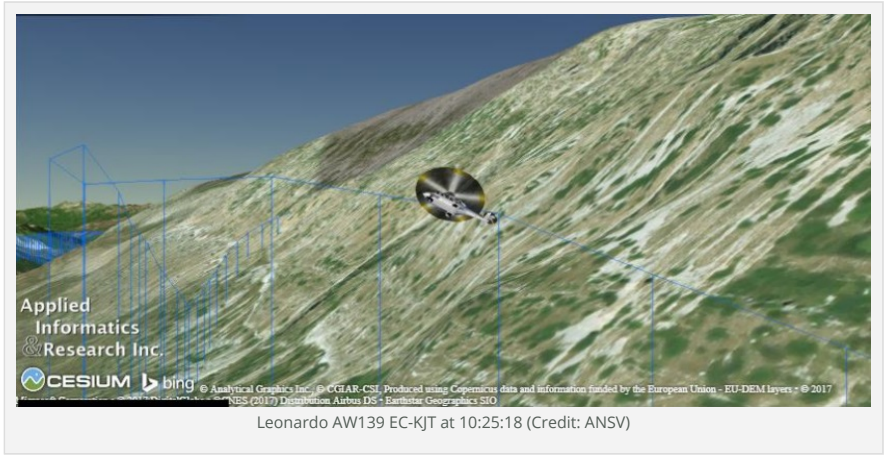
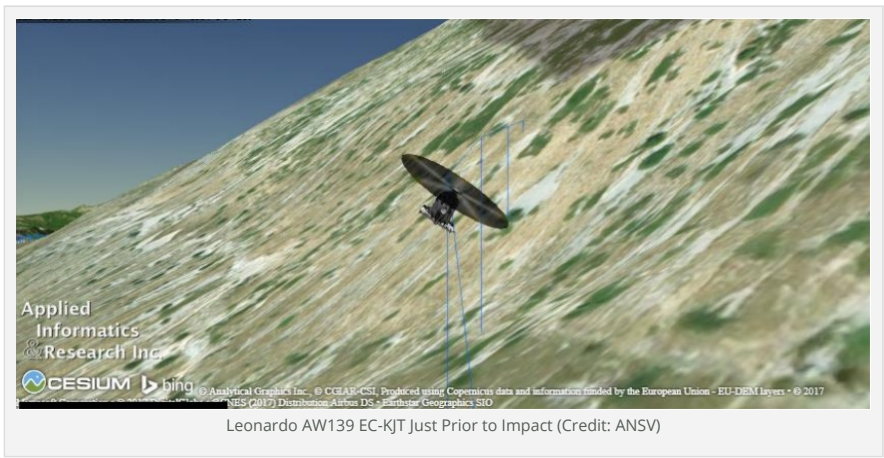
The helicopter then turned towards high ground and impacted against the south-west side of Monte Cefalone at c10:25:43, less than 2.5 minutes after take off.

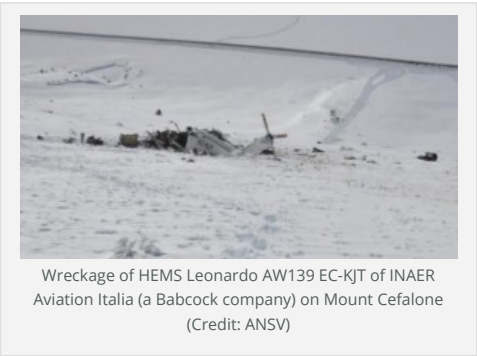
The 6 occupants died on impact. The **ADELTA** activated and the 406 MHz signal was received by the **COSPAS-SARSAT** satellite system. The wreckage **was recovered under slung by Chinook**.
